The restoration of the Martinikerk, Groningen, 1955–1975

PIETER LAUWRENS DE VRIEZE*

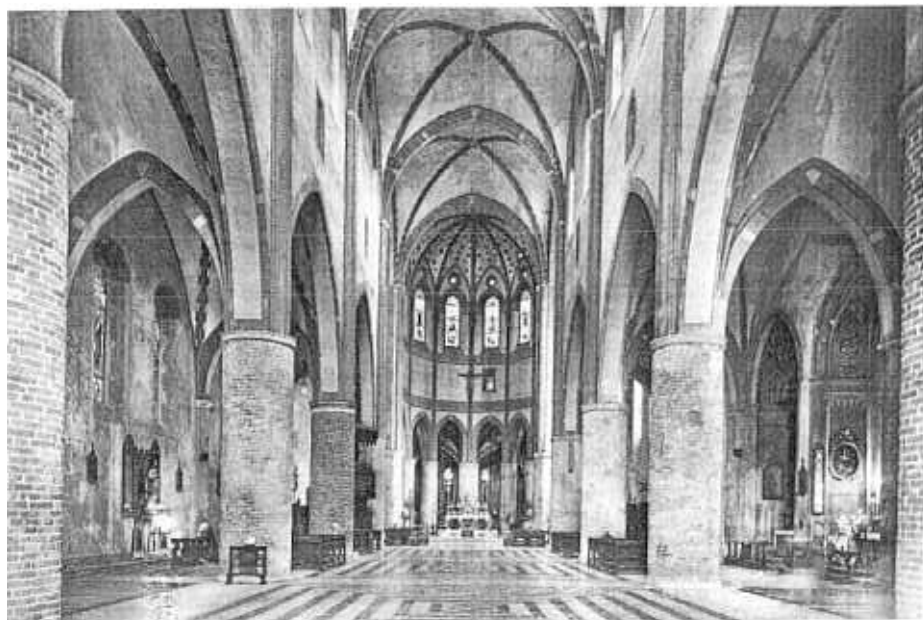
FIG. 5. Piacenza: interior of church of San Francesco (c.1278) showing the pillar in the central axis. (Photograph: Bromofoto, Milan)

Considering that most churches in the Netherlands were based on older examples elsewhere, it would seem appropriate to try to trace a model for the Gothic choir of the Martinikerk. It seems that this may be found in the church of San Francesco in Piacenza in northern Italy, a cruciform basilica which was completed in about 1278. Although the choir is much shorter than the one in Groningen, the similarities between various details are nonetheless striking. Whereas the end wall of the choir of the Martinikerk is hexagonal, that of San Francesco has four sides. The choirs of both churches are equally broad, but the seven columns in Groningen are far closer together than the five in Piacenza: so much so, indeed, that the space between the columns is less than the diameter of the columns themselves. The longitudinal axis in San Francesco thus also incorporates a thick round pillar, which, like its neighbours on both sides, is made of red brick and topped by a thin circular moulded cap of stone, a rudimentary capital. The pillars support high pointed brick arches covered in red plaster with the joints picked out in white, corresponding exactly with the original design of the Martinikerk. In Piacenza, the walls above these arches are flat and consist of white plaster, with colonnettes rising from the top of the heavy columns to the springings of the vaults, at which point they in turn are capped by small stone capitals with simple mouldings (*Fig. 5*). The plasterwork of the colonnettes is red with the joints painted white. In the Martinikerk the area above the arches consists of a further series of pointed arches, originally containing windows which looked out onto the roof construction of the ambulatory. Otherwise its design follows the Italian example. The church of San Francesco features lancet windows above each of which is a small window in the shape of a hexafoil. Finally the choir with its four-sided end wall is covered by groin vaults plastered in white and decorated with big and small red painted stars. The ribs, which converge in a multi-coloured rosette, are also red with the joints picked out in white.

Although other examples of choirs with equilateral end walls exist, the possibility that the architect of the Martinikerk had studied San Francesco in Piacenza cannot be ruled out. Once the choir was completed, in about 1425, it was decided to start work on altering the nave. By that time attitudes to Gothic architecture had changed and the

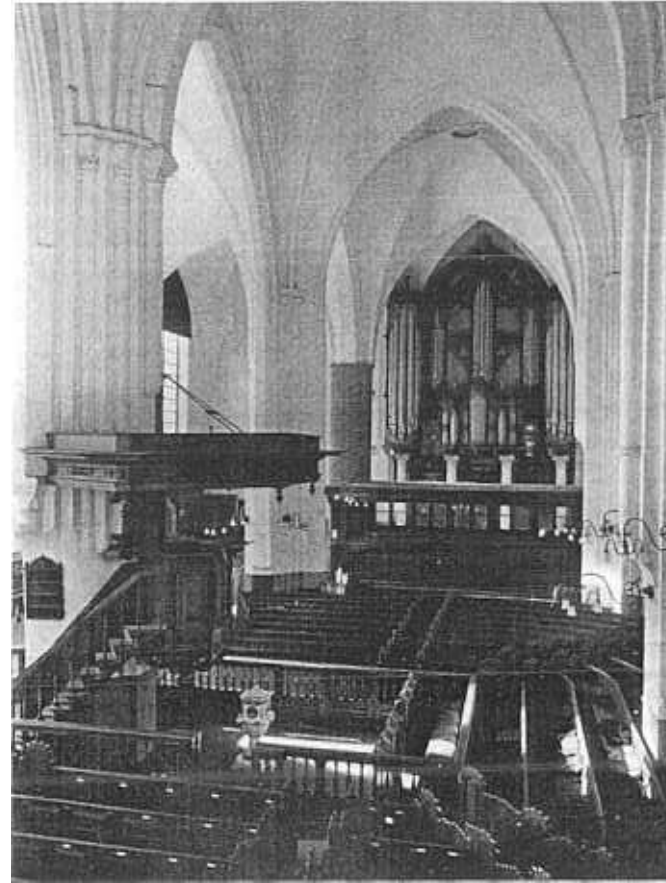
FIG. 10. Interior of the nave looking westwards, with the Schnitger organ. (Photograph: Agtmaal, 1933)

Two architectural styles have been preserved in the nave (Figs 9, 10), together with their characteristic colours, i.e. the Romanesque-Gothic (c.1250) and the late Gothic (c.1450). The former style is evident in the vaults with coloured ribs and tendrils painted on the panels; the acoustic vases with coloured decoration in the vault of the northern transept; and

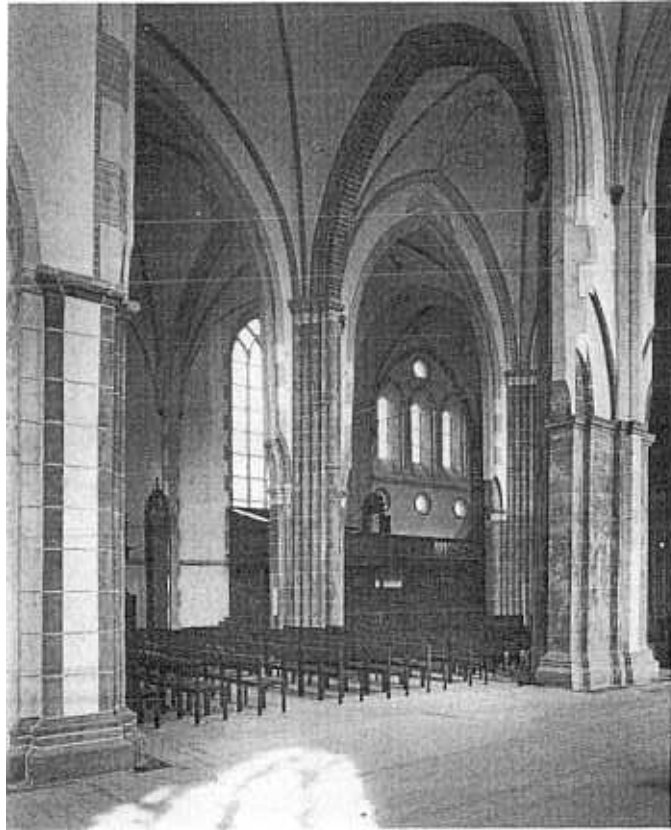
FIG. 11. Interior of the nave, with chairs. In the centre the north wall of the transept, with Romanesque-Gothic windows which have been partly reconstructed and partly restored. (Photograph: *Publicam*, 1976)

the imitation stone pillars (dark grey), carved foliated sandstone capitals and several two-dimensional capitals painted onto the plaster. It was decided to restore the Romanesque windows in the north and south transepts as a reminder that the Martinikerk is the Romanesque-Gothic mother church in the province of Groningen where there are still about forty smaller thirteenth-century village churches.
