# **Rigidity versus Ductility as an Exception in Timber Structures Planning in a Moderately Seismic Area**

*(The Rigid Timber Trusses Designed to Strengthen the Vasari's Timber Ceiling in Palazzo Vecchio, Florence)*

Pier Paolo Derinaldis, Gennaro Tampone

*University of Florence, Dept. of Restauro e Conservazione dei Beni Architettonici*

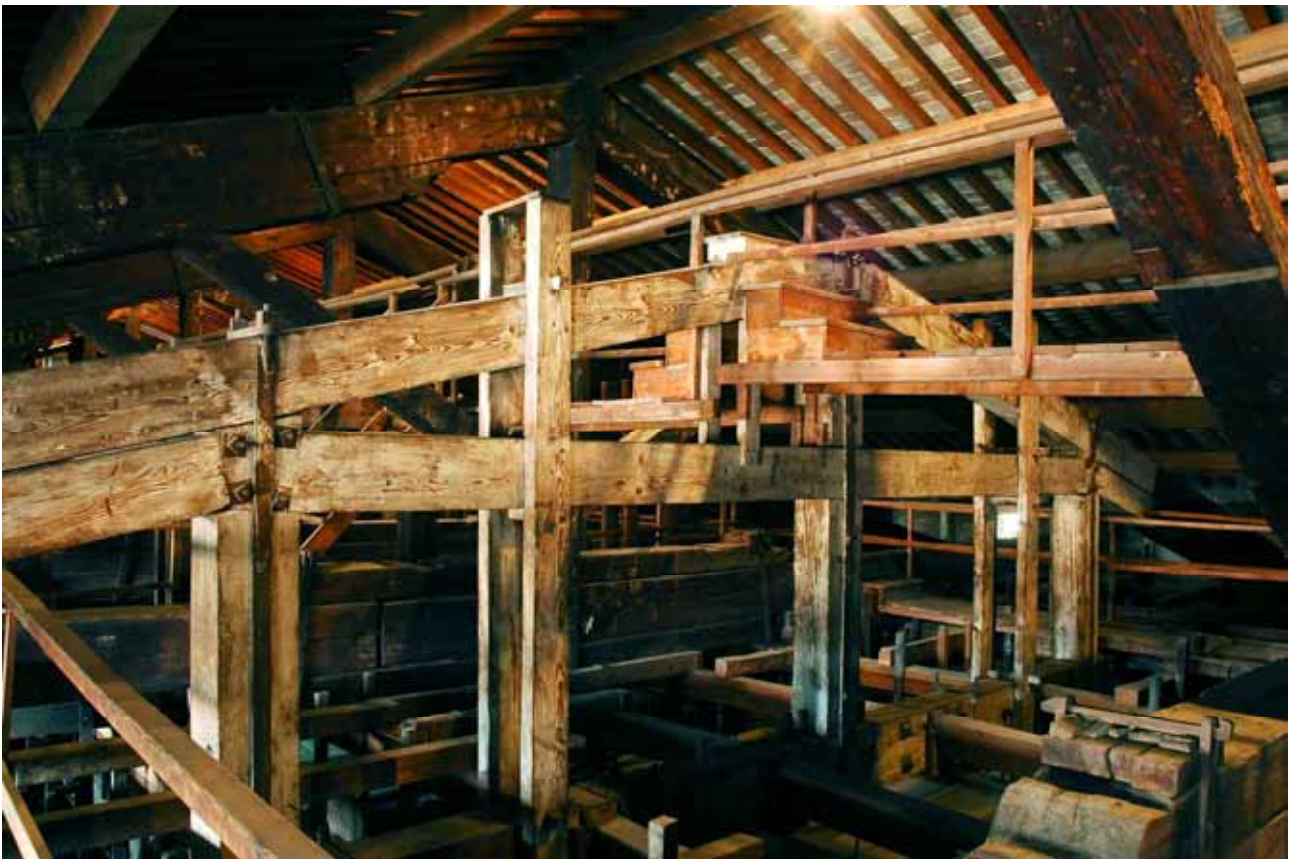
Figure 1: General view of the "soffitta" (the garret) of the Salone dei Cinquecento

The Vasari's work consists of a system of classic trusses - two rafters, kingpost with two struts, chord of two jointed pieces - of extraordinary span (almost 25 m), a great bay (4 m average), meant to support the covering and sustain as well the heavy false ceiling which is hung to the chords of the trusses, according to the system in use at the time; the trusses are equipped with excellent iron fittings and the nodes and the central connection of the chord are stiffened with iron ties in the shape of stirrups completed with gibs and cotters.

The ceiling is composed by longitudinal joists resting on the chords of the trusses to which is suspended a faint, thin horizontal frame of joists and planks; the latter are placed in the vertical and horizontal plane, boxed and arranged in a way to resemble, from the intrados, a set of principal and secondary beams with the lacunars of a real ceiling.

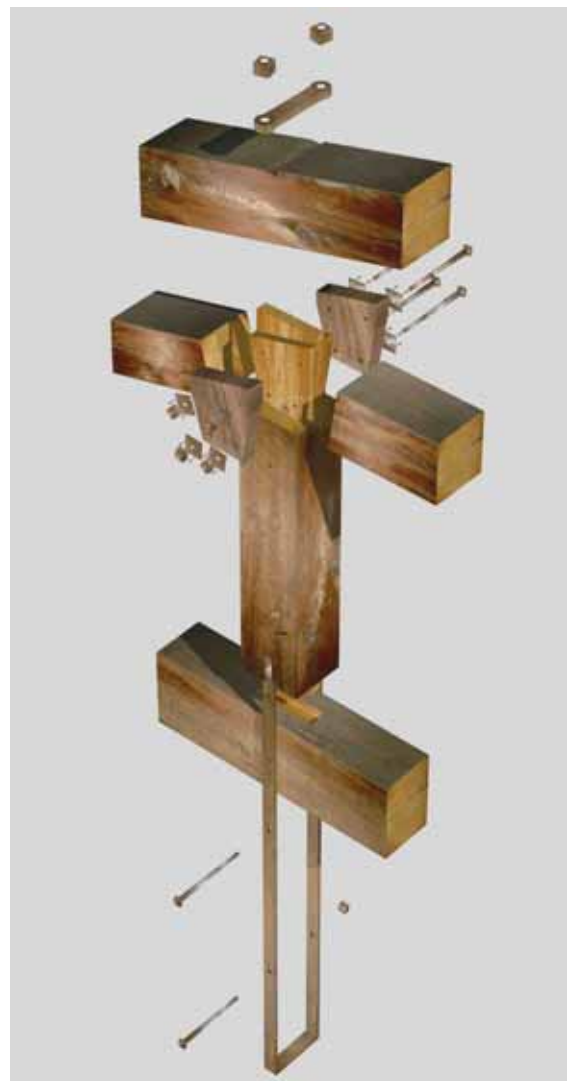
Figure 3: Exploded axonometric view of the node of the same truss. Two "voussoirs" of hard wood (oak) have been inserted between the concurring members to convey the stresses
