HERITAGE WITHOUT PAPER

RECOVERY EFFORTS FOR PROTECTION OF CULTURAL HERITAGE IN THE HISTORIC CITY OF NABLUS, PALESTINE.

Eman Assi *

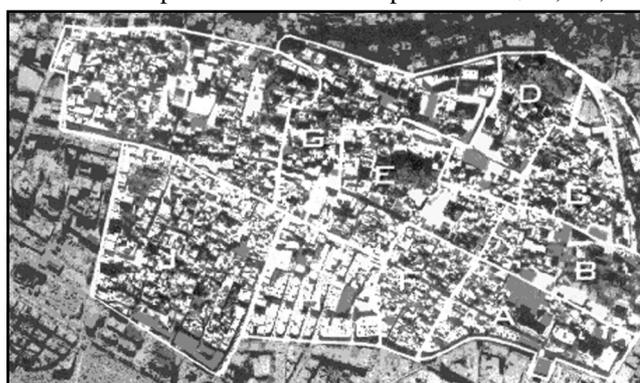
Map of the Old City of Nablus: Classification of Zones for survey purposes, where grade 4,5 with red color are totally damaged and grade 3 with yellow color are partially destroyed

Following the preliminary Post-Disaster Damage Assessment Report that was submitted to UNDP, and the discussion held at Nablus Municipality with UNDP and representatives of international donors. The disaster field investigation assessment has been prepared according to the categories of damage evaluation adopted in the European Macro Seismic Scale EMS 98 as shown in tables 1 and 2. The green color represents grade I and II (light damage). The yellow color represents grade III (partial damage). Whereas, the red color represents grade VI and V (total destruction).

It was observed that destruction caused by the Israeli invasion in the Old Town affected the whole area, damage was distributed in all quarters. It touched several building of different use. Results of the inventory carried out in the Old Town revealed that 64 Buildings or group of buildings were very badly damaged or totally destroyed (Grade 5 & 4). The total cost for reconstruction amounts to \$9,065,775.

Two hundred and twenty one buildings or group of buildings were partially damaged and need urgent repair and renovation. Urgent intervention is needed in many cases as the urban fabric of the Old Town forms one mass. Thus weak or unstable buildings will weaken and endanger other attacked structures in case of collapse. The total cost for repair reach to \$ 14,912,300.

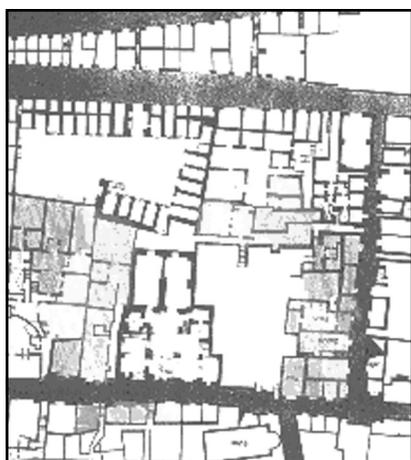
Kanaan soap factory site

The destroyed site consists mainly of two soap factory buildings (Kanaan and Al-Nabulsi that are totally destroyed) and a group of houses (shabaru, Istetaiyeh, shakhseer, Zatar, Khalili, Johari, Younis and Alfi families, that are partially damaged). The site with total approximate area of 8000 m squared lies at the western side of Old town.

The two destroyed soap factories were among thirty soap factories used to be functioning in Nablus in late 18th century. The Kanaan soap factory was an exceptional example for soap factory buildings in Nablus because of its unique design. The destruction of the two soap factories endangered the adjacent buildings and influenced the structural stability of the whole surrounding residential blocks, where 17 families are living in 7 traditional courthouses. The still standing structures, of the surrounding because of its unstable conditions threatens the safety of people who are living and moving in and near the site. Families were asked to evacuate the building and were offered temporary accommodations. The destruction of the site has also damaged the existing urban fabric of the historic city and changes its visual spatial qualities. What used to be a narrow dark path walk becomes a wide street with large empty space that is filled with rubble and parts of damaged buildings around it. As a result of the initial evaluation of the structural and physical conditions of the site and its surrounding, immediate intervention is recommended.
