Areas of concern

Old Colombo, Sri Lanka

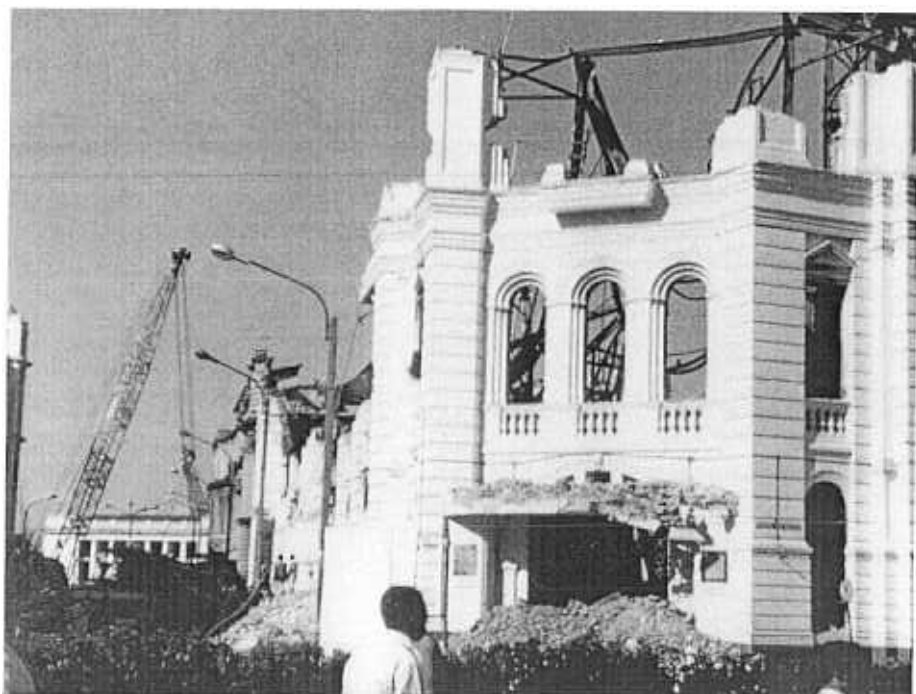
FIG. 1. The demolition of the fire-damaged Grindlays Bank, York Street.

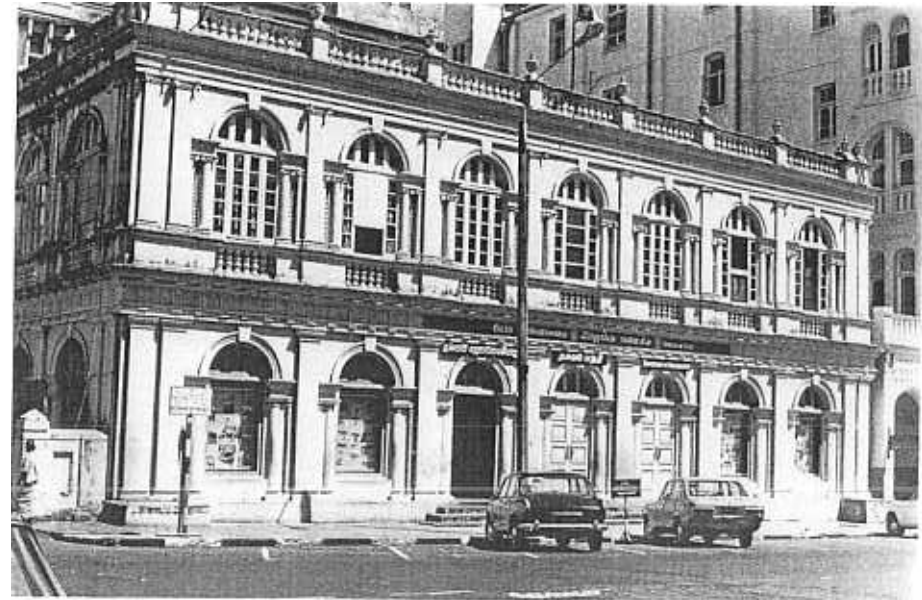
FIG. 2. Ministry of Information, Prince Street.

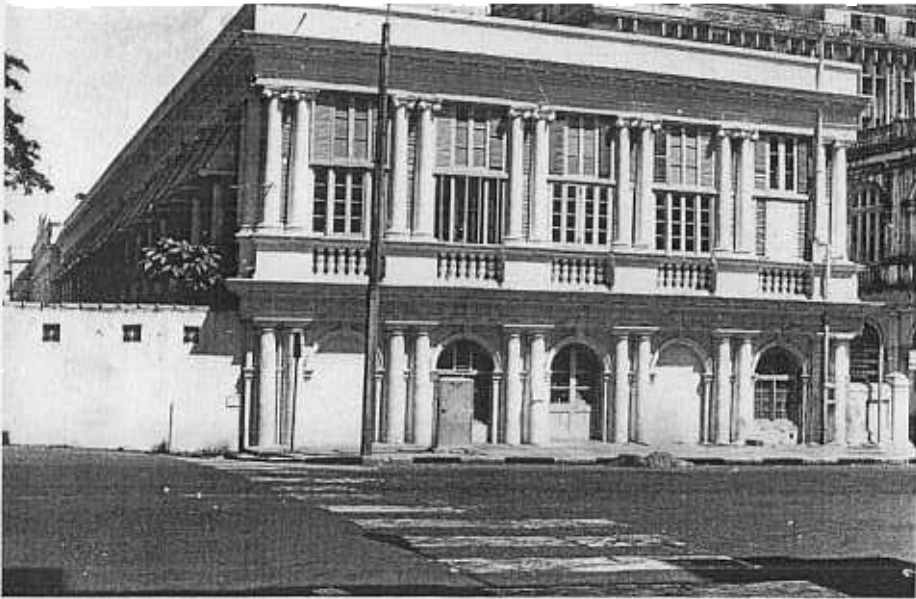
FIG. 3. The Office of the President, at the corner of Queen Street and Prince Street. This was the seat of the colonial government until 1929, and was completely renovated in 1948.

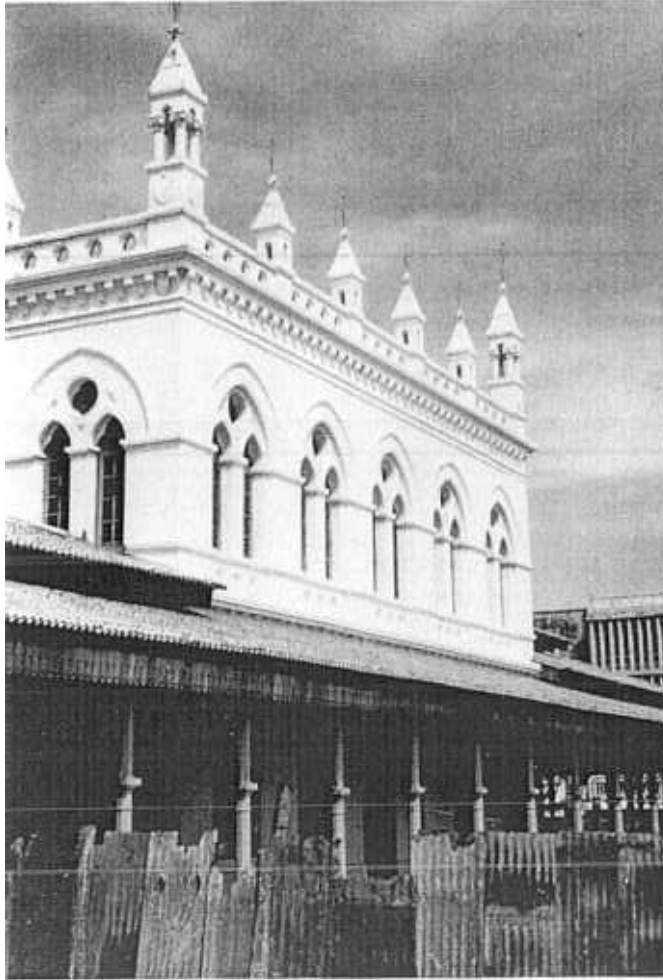
FIG. 7. The old Town Hall and the Edinburgh Market, Main Street.

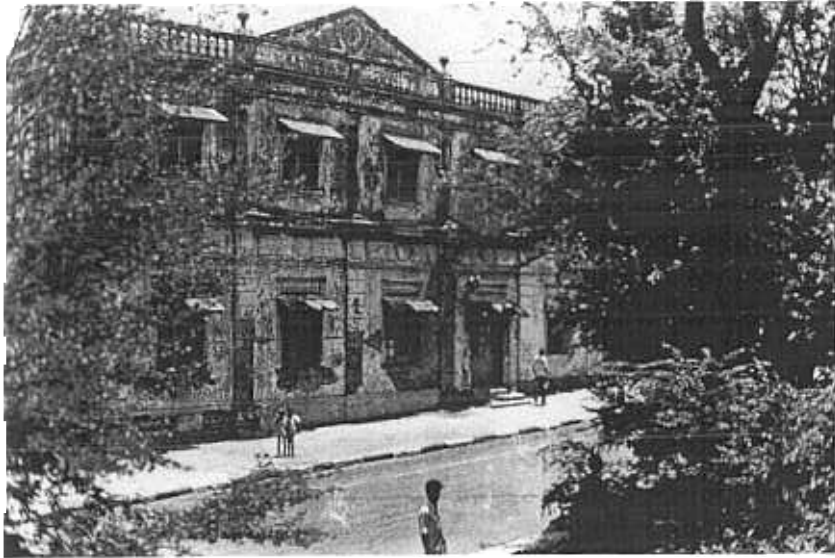
FIG. 11. A decaying building in Mihindu Mawatha, dating from the late nineteenth century.
