CZECH REPUBLIC

World Heritage and Development

Prague – a World Heritage Site in the Shadow of Commercial Projects

The huge floods that hit much of Bohemia in August 2002 also deeply affected our cultural heritage, apart from human tragedies and considerable damage to the environment, factories, infrastructure and agricultural areas (see *Heritage at Risk, ICOMOS World Report 2002/2003*, pp. 71–81). Already during and immediately after the flood, various rescue operations started. The following brief case-studies inform you of some selected remarkable cases of these activities.

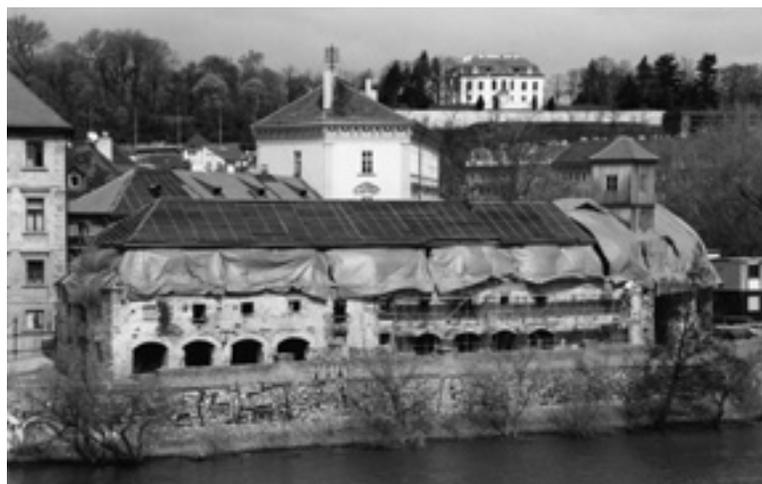
Prague, the large river bank area of the former Herget Brickworks in 2000. A typical picture of the forced re-adjustment of historic structure to new use

The large area of riverbank of the former Herget Brickworks dating from the end of the 18th century was adapted during 2000–2003 for a completely new tourist use – restaurants and a commercial exhibition hall. As part of the reconstruction, historical vaults on the ground floor were vandalised by being torn down, and large openings were broken through the façade facing the river, in an originally solid wall, for the benefit of a view for the restaurant guests. Also, an apartment building with underground parking is planned to be built in the exclusive Herget Brickworks area.

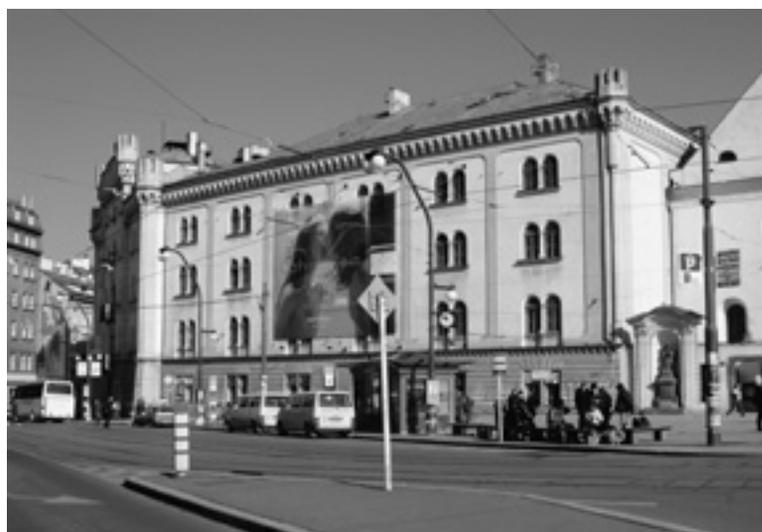
Prague, the historic Josefská Barracks from Republiky Square. The vacated building is ready for demolition. Only the façade is to be preserved.

The intended rebuilding of the former Josefska Barracks at Republiky Square is so far the largest and most upsetting damage to the cultural values of the historic core of Prague since the fall of the communist regime in 1989. The area of the barracks was built up in 1857–61. It includes the main three-wing accommodation building near the square, the riding school along Na Porici street and the vast courtyard with free-standing stables. The area is protected as cultural heritage. In its place an enormously big shopping, entertainment and administrative centre is to be built. The total area of the site is expected to be built over. According to the project approval only the façade and some parts of the main building facing Republiky Square and the riding school are to be preserved. Behind the scenes a giant new building is planned with a

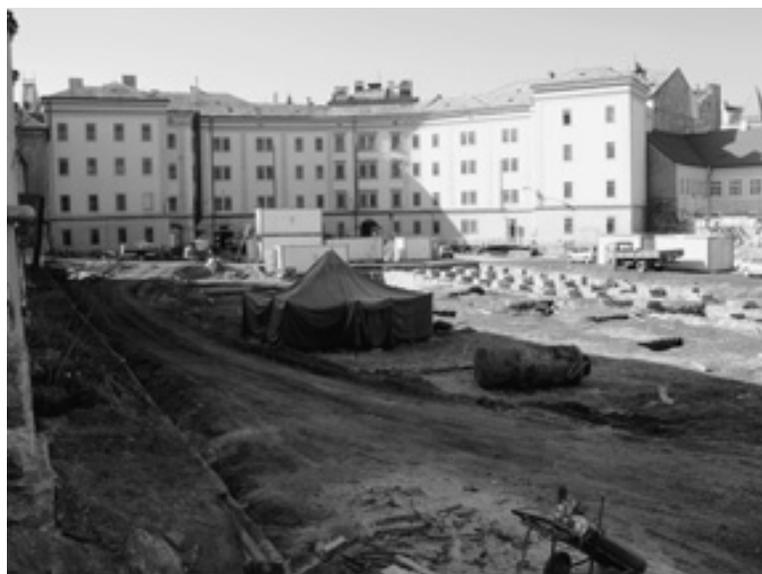
Prague, the view over the former courtyard of the rear façade of the main building of the Josefská Barracks. The stables have been demolished already. At present rescue archaeological research is being done in the area. According to the house in the picture in the upper right sense can be made of the sizes of the parcels of land and the character of the surrounding built-up area. This can be compared with the planned new building that is to take up the whole free area in the photograph.

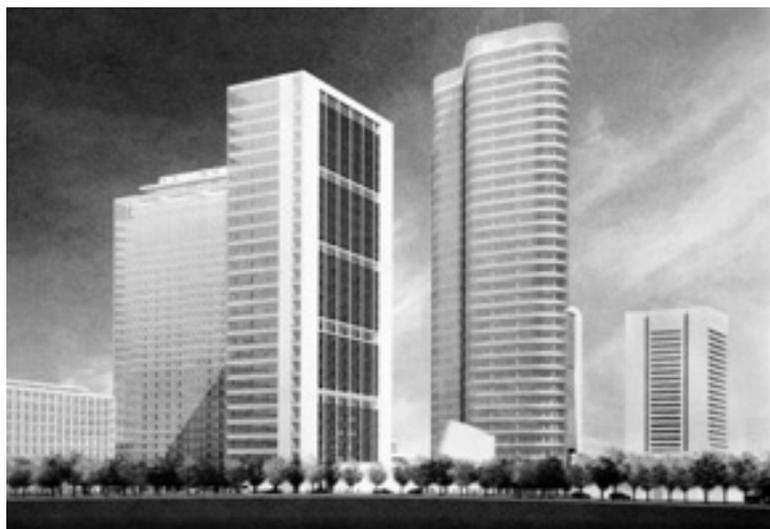
The model of the new group of still substantially taller high-rise buildings proposed for Pankrác Plain by Richard Meyer. A precedent that would find a number of eager successors.

In 2001, the firm ECM Radio Plaza announced the project for a further wave of filling Pankrac with high-rise buildings, this time as high as 150 m. The developer advanced skilfully using the world-renowned architect, Richard Meyer, as the Trojan horse, in setting out the project. His design has of course indisputably high qualities, if it were intended for another place. Also, the developer won very active support for the project from the mayor of the local city quarter Prague 4. The mayor self-confidently stated to the media that his quarter had the right to have its own 'Hradčany' (that is, its own 'Prague Castle' as the city's most visible structure). The comparison really gets to the core of the problem. Indeed, the project is trying, quite consciously and with breathtaking arrogance, to 'outdo' the Prague Castle in the current extremely impressive panorama of historic Prague. Apart from the mayor's support, the investor also achieved an unusual welcome from all sections of the Prague Municipal Authority responsible to approve the project.

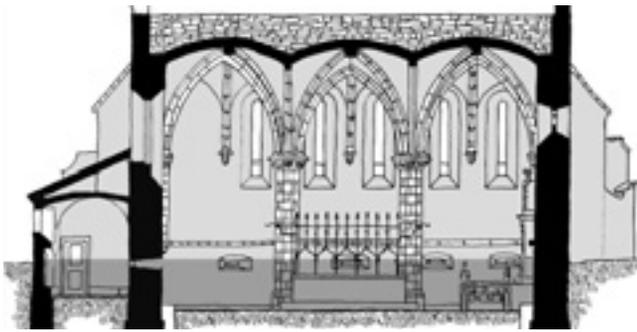
Prague, longitudinal section of the Altnai Synagogue shows the location of the two vast buttresses, almemor and the box for the torah (aron hakodesh). Marked in blue is the level of water during the 2002 flood.

In August 2002 water penetrated the Synagogue's newly restored interior during the large flood and inundated the interior to an approximate height of 1 m. Thanks to well-organised rescue works by Prague's Jewish Community, significant state financial

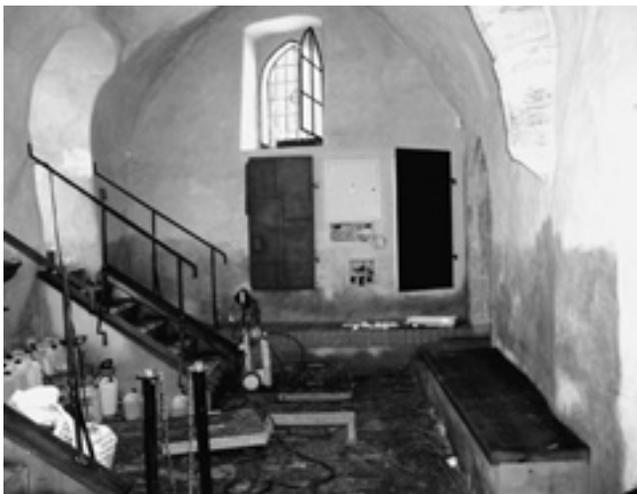
The southern hallway is the oldest addition to the Synagogue, it originated, evidently, already during the construction in the last quarter of the 13th century. The condition shortly after the falling off of water during the 2002 flood.

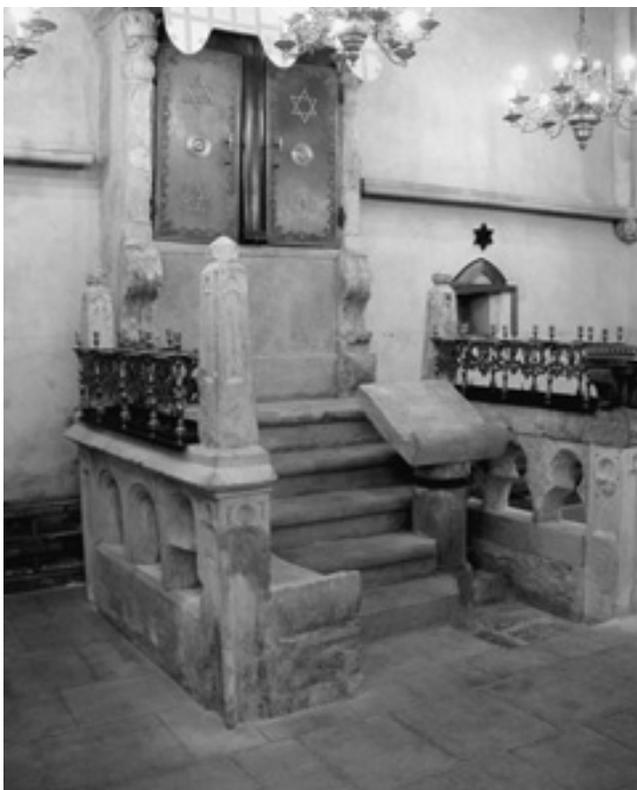
The most valuable part of the interior of the Altnai Synagogue from the liturgical and ancient monument point of view is the box for the torah (aron hakodesh). The condition after the performance of the conservators works in 2002 within the framework of the removal of the consequences of the flood.

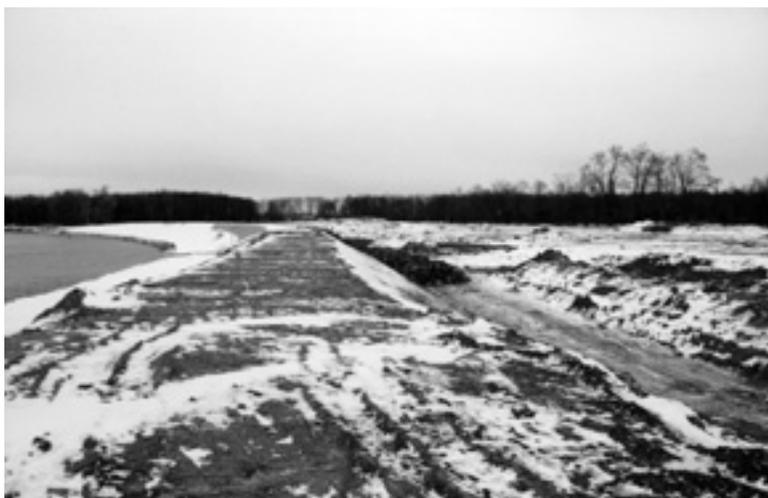
Veltrusy, a newly built dike on the western side of the park

In the first stage, repairs focused on the basic physical security of the place by replacing the destroyed dike at the river mouth. Silted sand and soil were removed and by contrast hollowed out areas were back-filled.

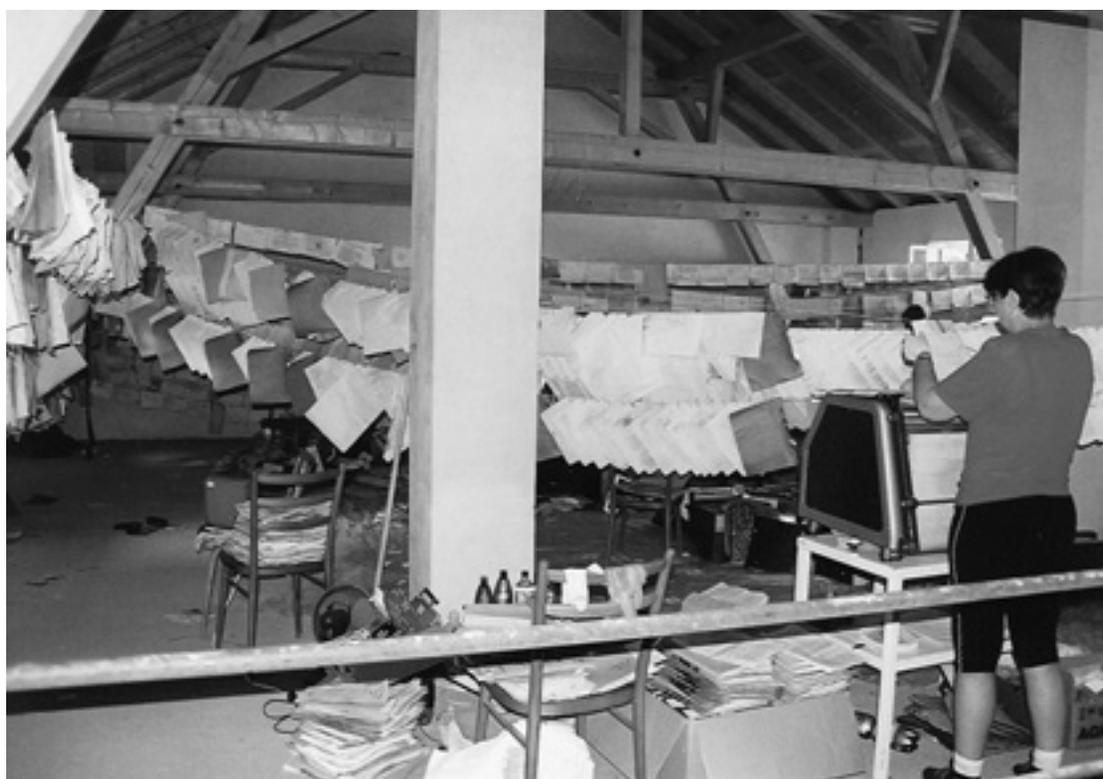
Ceské Budějovice, in the conference room of the institute the flooded files were dried

Sites at Senovazne Square, the files and plan archives were flooded and irreparable damage was caused by flood to the photographic archives. For almost a month the Institute's routine program was interrupted and the staff of the historic monuments conservation section, assisted by volunteers, both students and colleagues from unaffected localities, separated the saturated documentation files and dried out the archival materials on lines stretched in the lofts, corridors and empty offices. Although the premises of the Institute reminded one rather of a laundry drying room, more than 80% of the agenda files, including photographic documentation was successfully saved in this way.

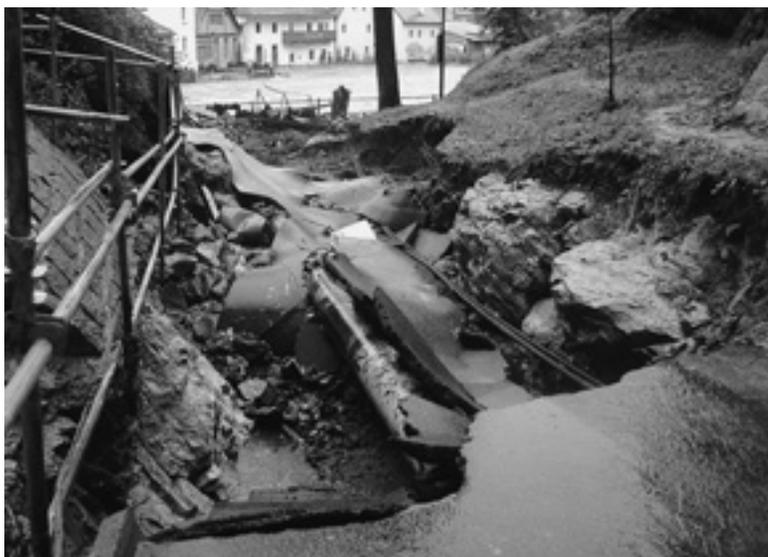
Český Krumlov, the condition of the access road under the Plášťový Bridge after the water falling off

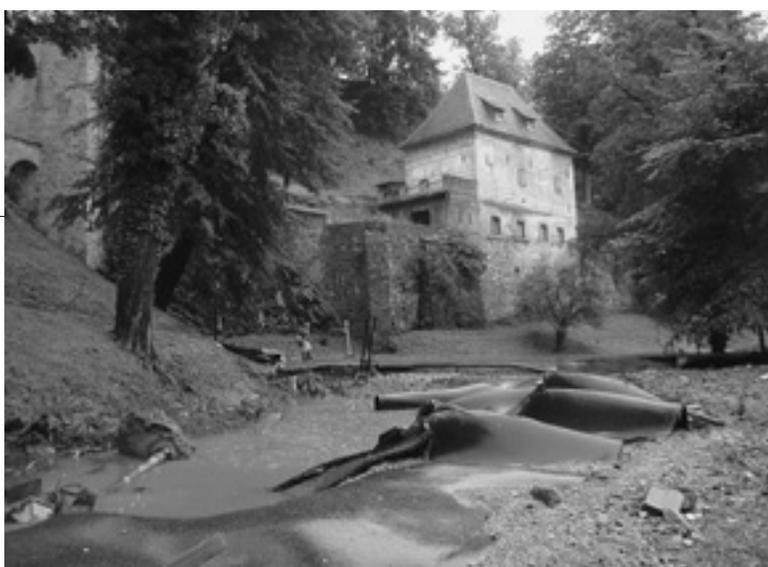
Český Krumlov, the brought down asphalt road in Jelenka

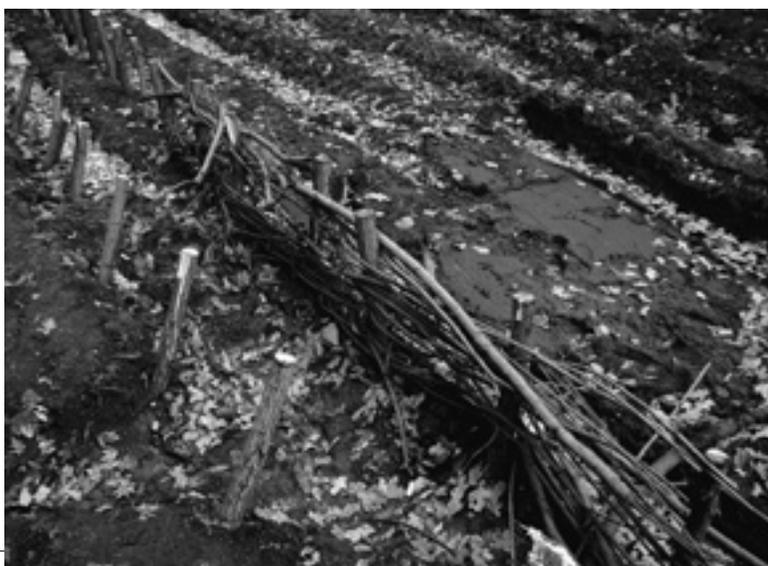
Kratochvíle, foundation of willow wattles on the bank of the brook near Kratochvíle
