SERBIA AND MONTENEGRO

Case Study 1 – Protection of archaeological excavation along the route of the future Niš – Macedonia highway

Case Study 2 – Smederevo fortress

Case Study 3 – Old cemeteries in Niš

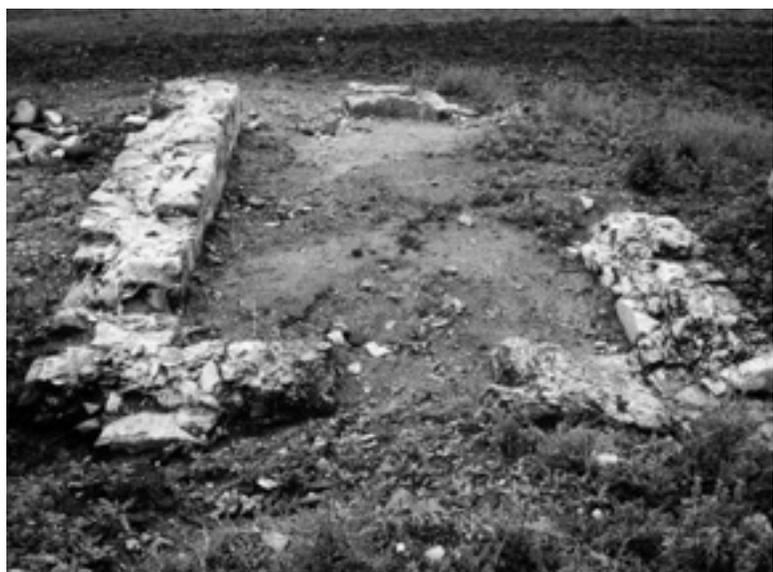
Archaeological site Crkvište, remains of sacred building (14th – 15th century)

The newly discovered archaeological sites are located directly on the route of the new highway, or in its immediate vicinity. Subsequent research indicated that only some of these sites will be endangered by construction work. The risk of damage to the partly excavated sites is multiplied by illicit excavations and treasure hunters. There is also an extremely negative attitude to medieval Orthodox sacred buildings and *necropoli* on the part of the local community in this part of southern Serbia. The risks of further damage to these heritage sites could perhaps be reduced if the archaeological sites were fully investigated, not only the area threatened by the highway construction, and if surviving architectural remains were appropriately displayed to the public.

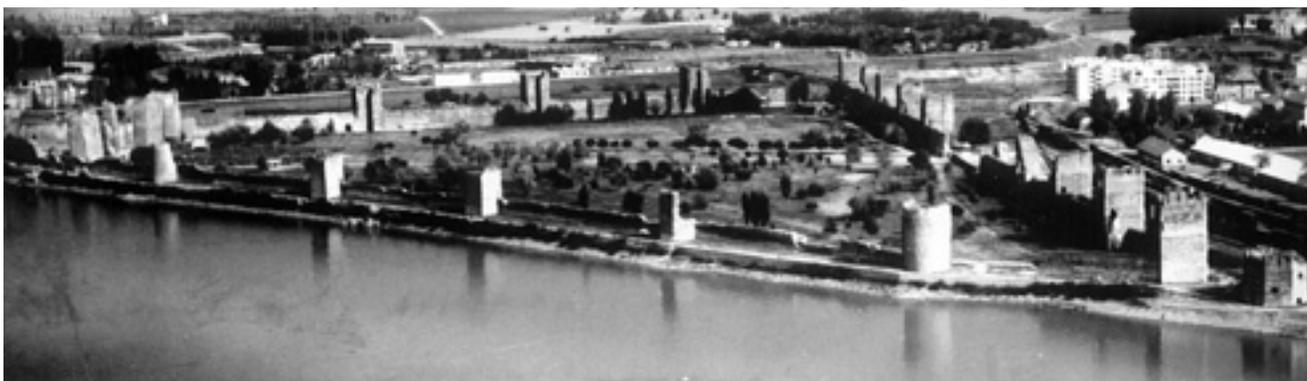
Smederevo fortress, fortification complex

times. During the period of its most intensive occupation, in the first half of the 15th century, the city of Smederevo was the main political, religious, economic and trade centre in this part of Europe, and a link between the Balkans and Central Europe. The fortress surrounds an inner area of 11 hectares, while its outer area extends to the surrounding urban structures. The grandeur of this fortress is manifested by 25 massive towers about 25 m high, connected by ramparts over 2 m thick. The total length of the ramparts amounts to 1.5 km. The city park is located inside the fortress, and is used occasionally for cultural gatherings, concerts, and fairs. The immediate surroundings of the fortress are used as a boat marina, the area along the river-bank as a river port, and the fort is also partly encircled by railway tracks.

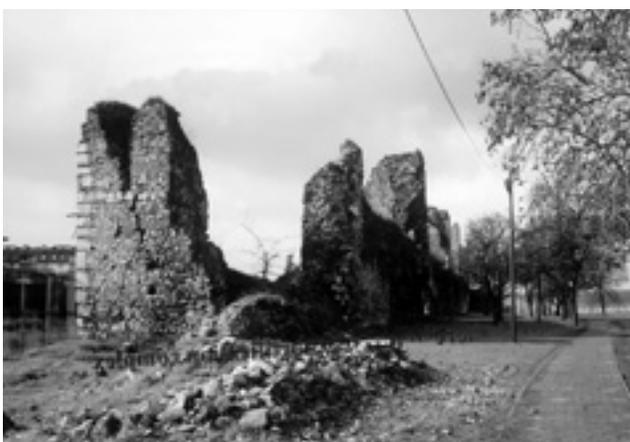
Smederevo fortress, detail

Different natural and unnatural factors currently affect the general state of this monument complex. The fortress suffered considerable damage during both World Wars. It was bombed several times. During World War II, the explosion of a munitions dump located inside the fort demolished a large section of the ramparts facing the city, while certain parts of the walls were loosened and dislodged. This situation remains unchanged up to the present day. During construction of the Danube hydro-electric plant in the Đerdap Gorge in the 1970s, a high water level defence system was erected. Before this, the fortress was flooded several times. Nevertheless, after the construction of the hydro-electric plant, problems appeared with high levels of ground water and ground instability on the plateau between the two rivers where the fortress stands. They caused a permanent risk of the walls and towers subsiding, and resulted in a serious disturbance to the stability of the entire complex. The railway station with its associated buildings is a particular problem, endangering the fortress and its satisfactory use given its location and function. There is also the ever-present danger of inappropriate structures being built around the complex, in the fort's immediate surroundings.

On the whole, all these factors have worked together over time to cause the slow deterioration of the Smederevo Fortress, primarily due to current existing renovation plans not being carried out.

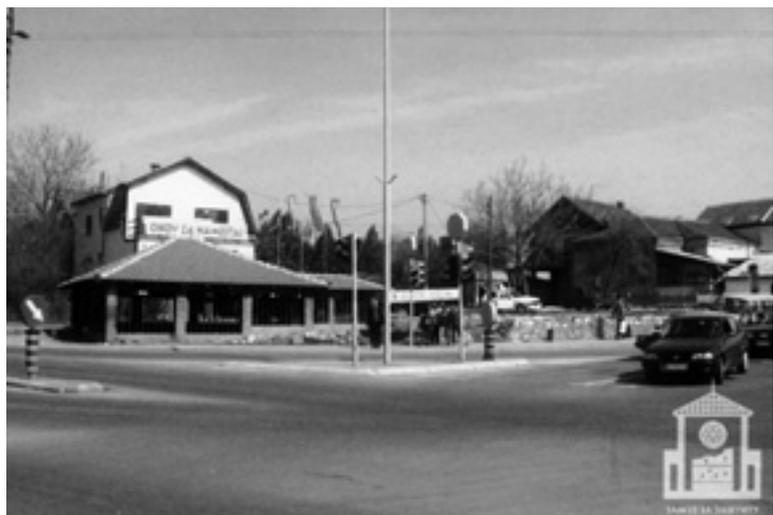
Niš, Basilica with martirium

Jagodín-mala, a late Classical and early Christian *necropolis*, extends to the north-east of the fortress, the area on which ancient and medieval Niš was located. It represents an extremely significant archaeological site because it was used for burial from the 4th up to the 12th century. Beside individual graves, there are built and group crypts. The most significant is an early Christian crypt decorated with frescoes (from the end of the 4th century), while the foundations of a *basilica* with *martirium* are located on the very edge of the *necropolis*.

Urban development and the construction of new residences threaten all these items, as well as the *necropolis* as a whole. Indeed, a settlement was first established here towards the end of the 19th century, and subsequent urban development has led to intense construction which continues unabated, although without city planning or control of what is happening at the site. Many crypts have been demolished as a result or used as foundations, cellars, or even septic tanks.

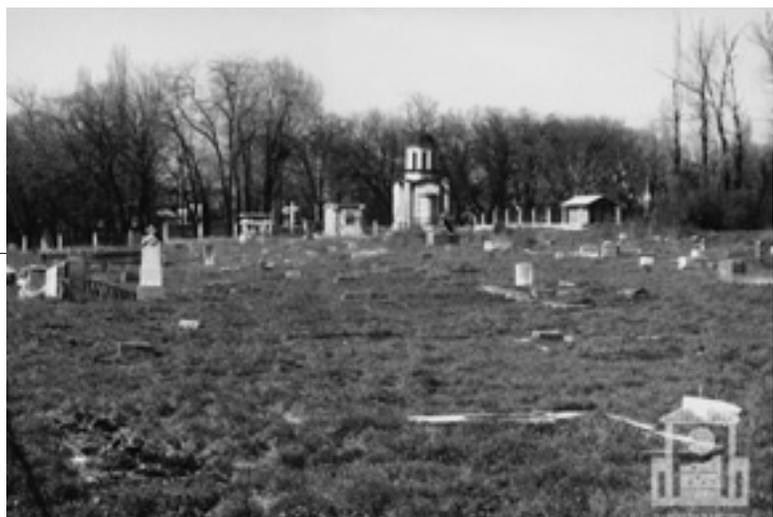
Panteleimon Cemetery was formed at the end of the 19th century, next to the Church of St Panteleimon on the north-eastern outskirts of the city, as an extension to an existing medieval and early Christian *necropolis*. Burials took place until the end of the 1940s. For many years since then, the cemetery was used as a children's playground, for grazing cattle, and for rubble and rubbish disposal. This resulted in most of the gravestones being pulled down, taken away, or covered over, while a number of graves were moved to other cemeteries. Today, only two family chapels and several gravestones remain visible. Part of the cemetery has been usurped by the construction of houses, while the remaining area is being considered as a possible city park.

Niš, St. Panteleimon Cemetery

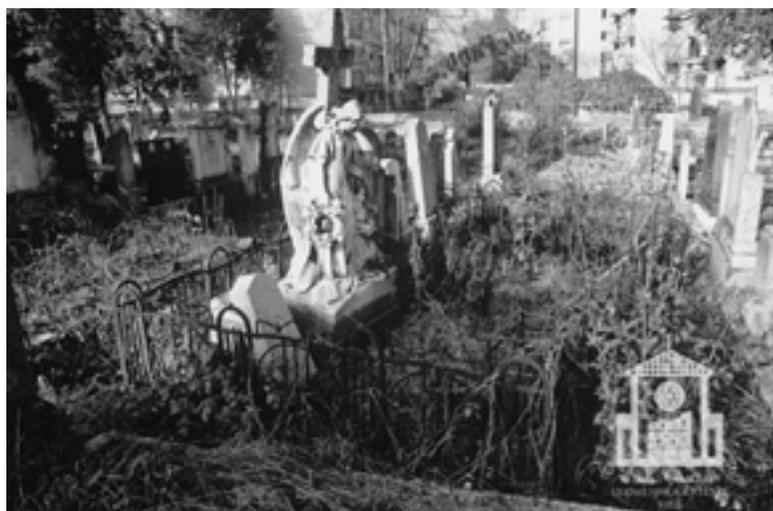
The problem with this graveyard, as with most old graveyards in Serbia, basically stems from general negligence by the community as well as the cemetery services responsible for their care and maintenance. This is why the graveyard is quite neglected, covered with weeds, hounded by bands of stray dogs, and turned into a dump. The council's care amounts to trimming the bushes each spring. As always, an excuse for such neglect is found in the lack of permanent funding for maintenance. The graveyard is still disorganised in the urban sense, with no structured paths (except for the main one), and with no lighting or guards; some areas present a very ugly picture.

The situation became alarming when, towards the end of 2003, a large number of tombs were damaged during a very short period

Niš, Old Cemetery

of time (maybe even during one single night). On this occasion of extreme vandalism, some 200 tombstones were damaged - pulled down, broken, or covered in graffiti. This event further violated the already quite degraded heritage values of the Old Cemetery.

In order to protect and preserve this cultural and historical complex, two models have been proposed. One is to turn the cemetery into a memorial park, and place it under permanent city care, the other to reactivate certain parts of the cemetery for burials, in which case the cemetery could rely on its own sources of funding. If the latter solution is adopted, strict criteria for burials, grave memorials, usage and maintenance must be adopted, because old cemeteries are quite often damaged by new burials and tombstones, that are incompatible with existing aesthetic and landscape values.

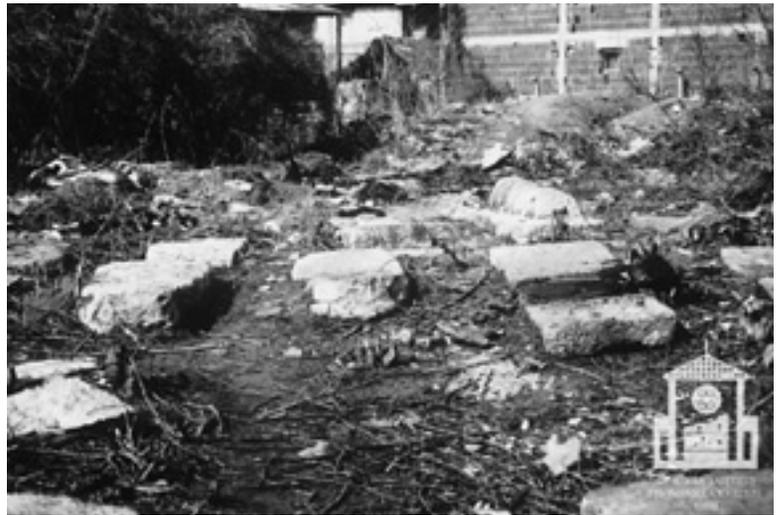
Many years of general indifference brought this cemetery to a very bad state; it is neglected and has deteriorated, but it has also been overtaken by illegal construction. In fact, a dense illegal Rom [Gypsy] settlement has appeared and grown in the northern part of the cemetery, with house foundations often being built into grave-stones, which are used to pave passages and yards, or even as furniture inside the houses. On the opposite side of the graveyard, an

Niš, Jewish Cemetery

illegally erected four-metre-high wall took over part of the cemetery and destroyed a large number of tombstones. A few months ago, someone dumped a large quantity of rubble and covered part of the cemetery. On this occasion, both the public and the responsible institutions showed some interest in the condition of this graveyard.

Because there are hardly any Jews living in Niš today, the impossibility of quickly and easily removing the illegally constructed buildings, and the lack of necessary financial resources, it is currently difficult to see a solution to save, restore and interpret this important cultural property.
